**NL INDUSTRIES/TARACORP SUPERFUND SITE GROUP**  
**Leed Environmental, Inc.**  
**Van Reed Office Plaza**  
**2209 Quarry Drive, Suite C-35**  
**Reading, PA 19609**  
**Telephone: (610) 670-7310**  
**Facsimile: (610) 670-7311**

November 19, 2019

**Re: NL Industries/Taracorp Superfund Site; Granite City, Illinois**  
**Second 2019 Semi-Annual Operation and Maintenance Inspection (November 2019)**

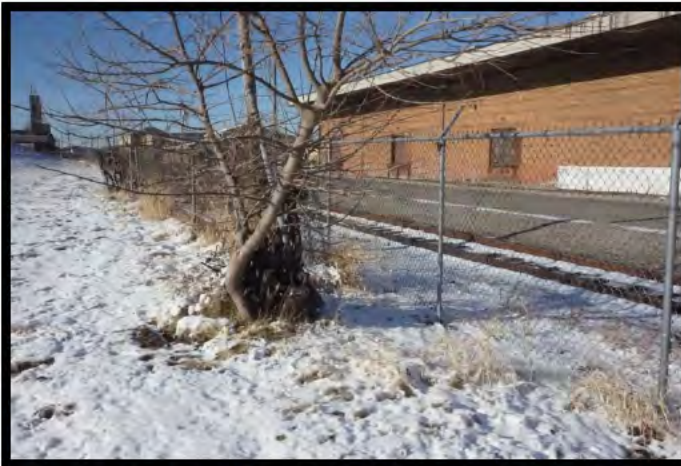
Photograph 63: Older and newer fence near former BV&G Truck Service buildings and along railroad tracks (view northwest).

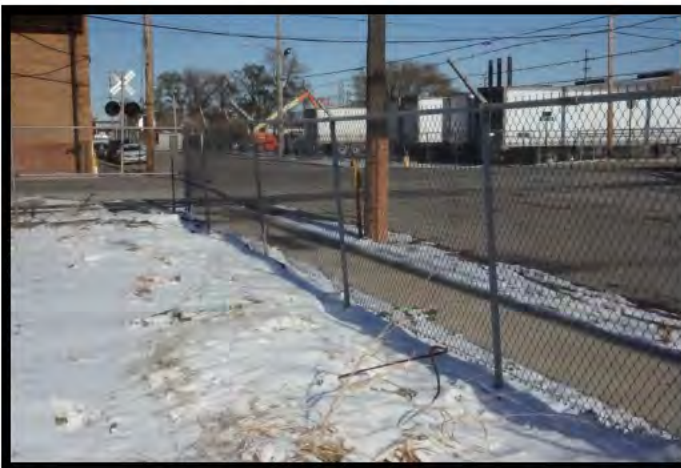
Photograph 65: Inside fence, corner of State Street and 16<sup>th</sup> Street.

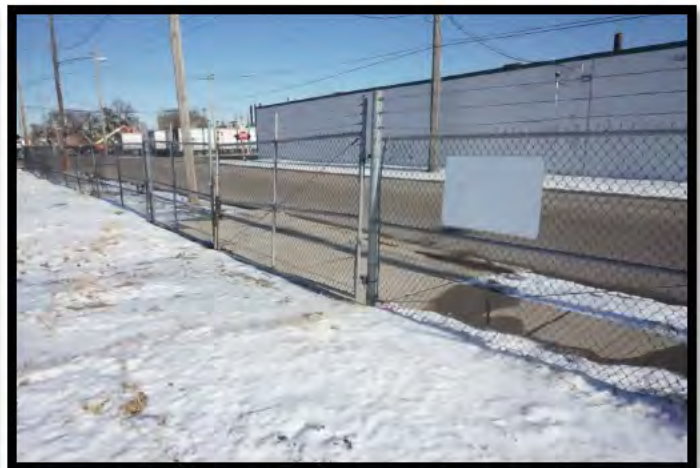
Photograph 66: Inside fence, gate along State Street.

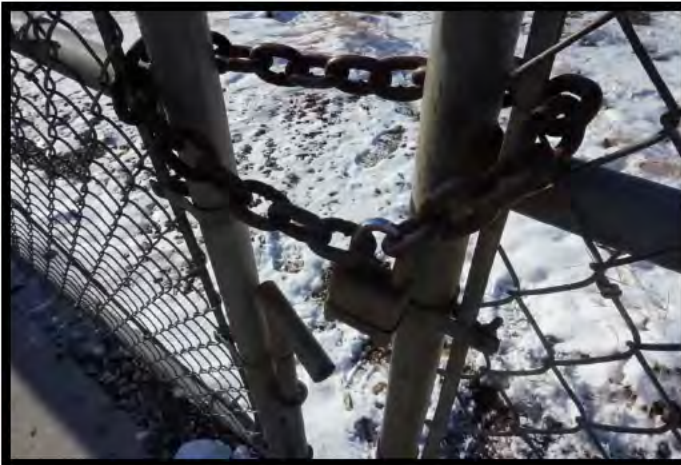
Photograph 67: Lock on State Street gate.

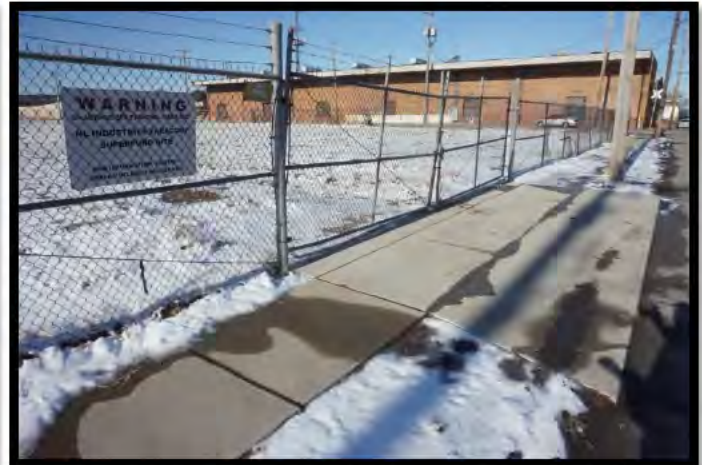
Photograph 68: Concrete entranceway gate near 16<sup>th</sup> Street and State Street.

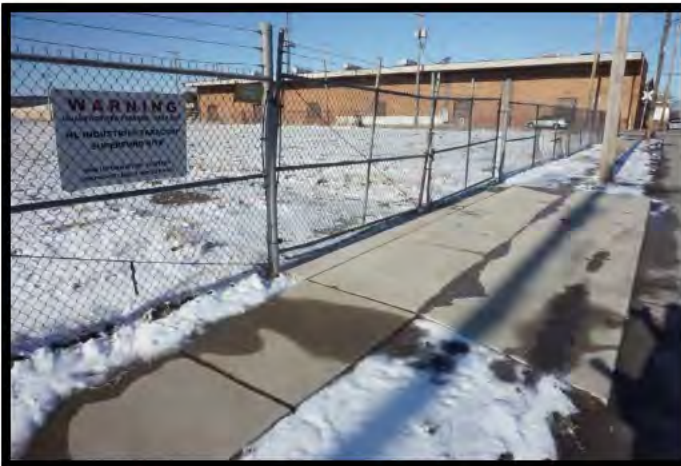
Photograph 69: Fence, warning sign, grass, and sidewalk along State Street.

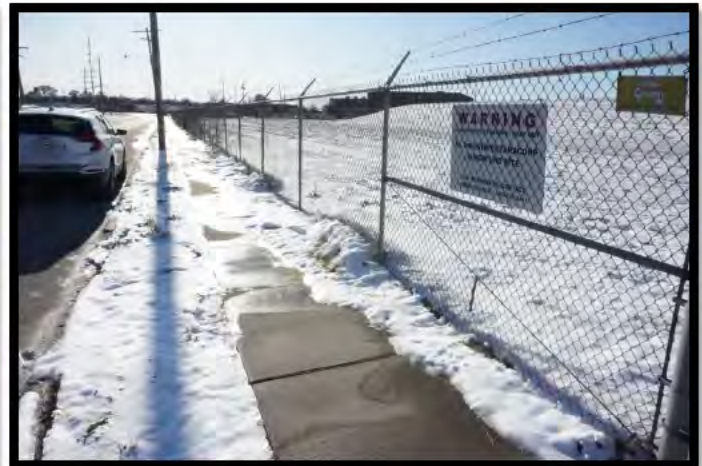
Photograph 70: Fence and sidewalk along State Street.

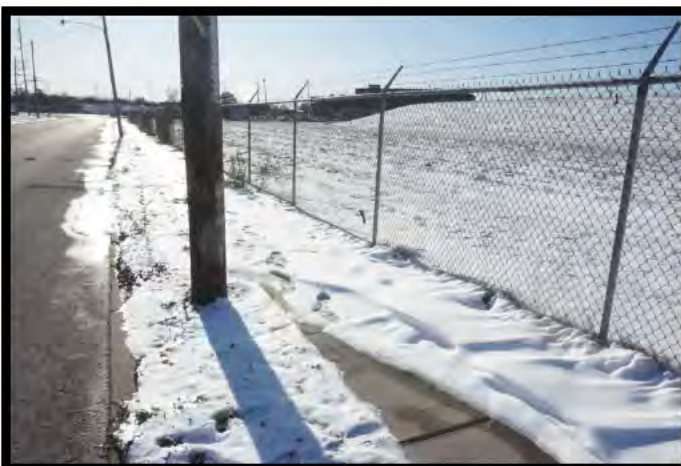
Photograph 71: Fence, grass, utility pole, and sidewalk along State Street.

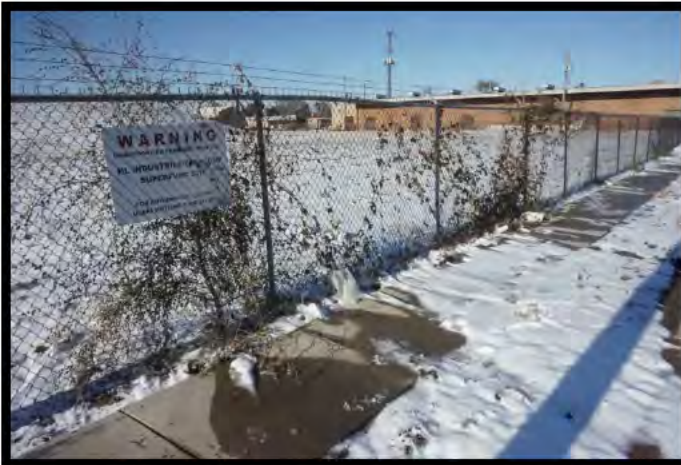
Photograph 73: Warning sign along State Street.

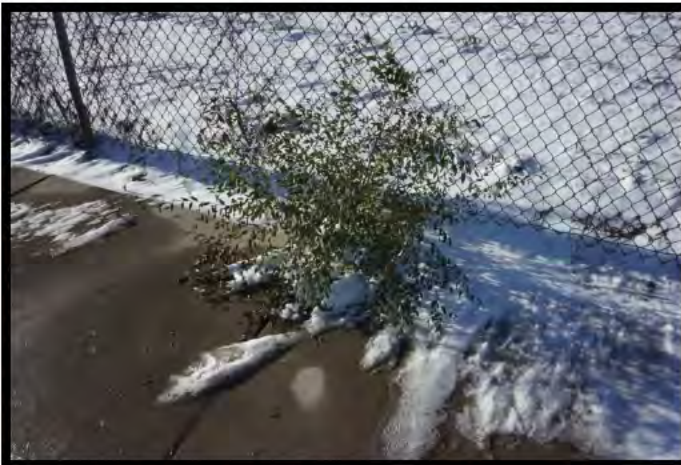
Photograph 75: Vegetation along State Street sidewalk.

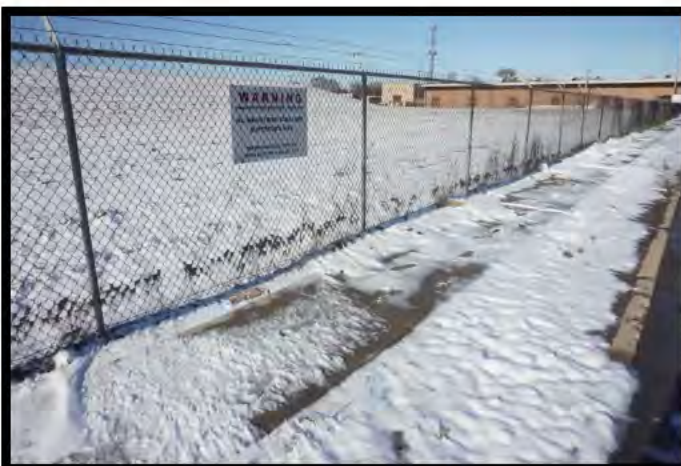
Photograph 77: Sidewalk along State Street.

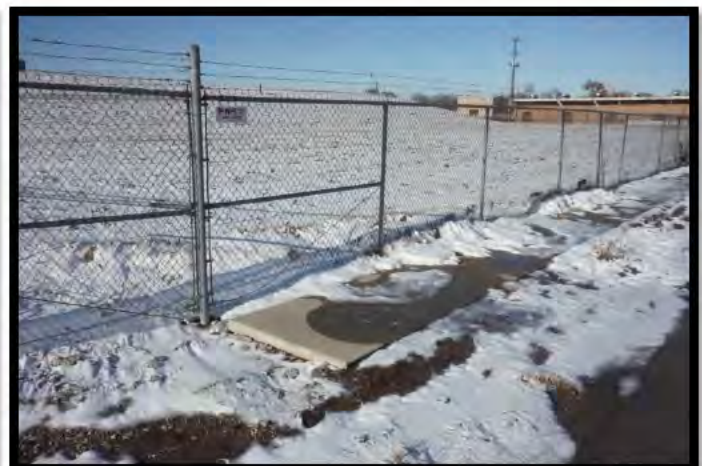
<b>Concrete Sidewalk (1555 State Street Property)</b>				
Evidence of cracks or other deterioration	Yes	No		
Comments			Concrete sidewalk is in good condition; no problems identified. Sidewalk was partially snow covered.

Photograph 78: Southern end of concrete sidewalk on 1555 State Street property (adjacent to former Rich Oil property).

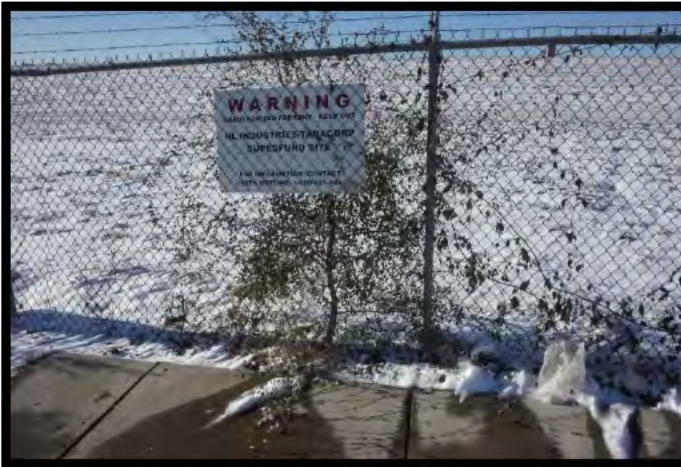
Photograph 79: Vegetation on fence along State Street.

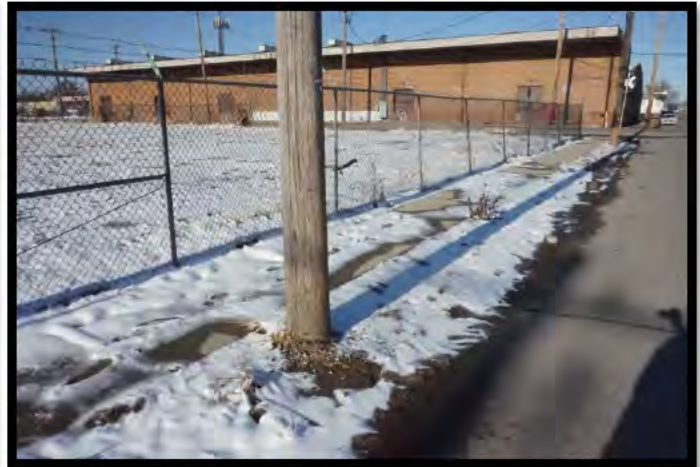
Photograph 80: Fence, grass, and sidewalk along State Street.

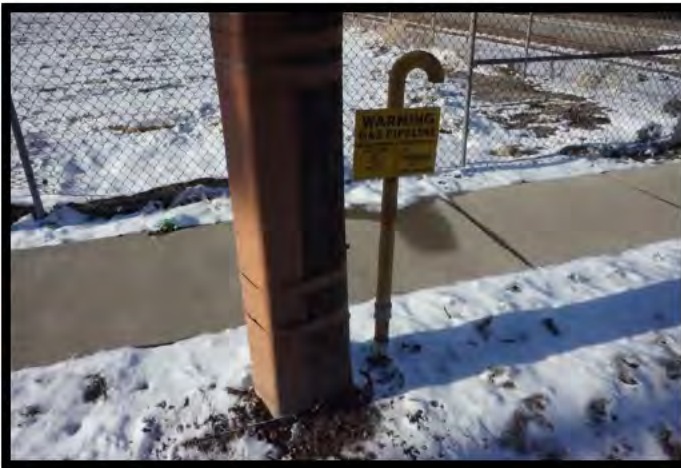
Photograph 81: Utility pole near intersection of 16<sup>th</sup> Street and State Street.

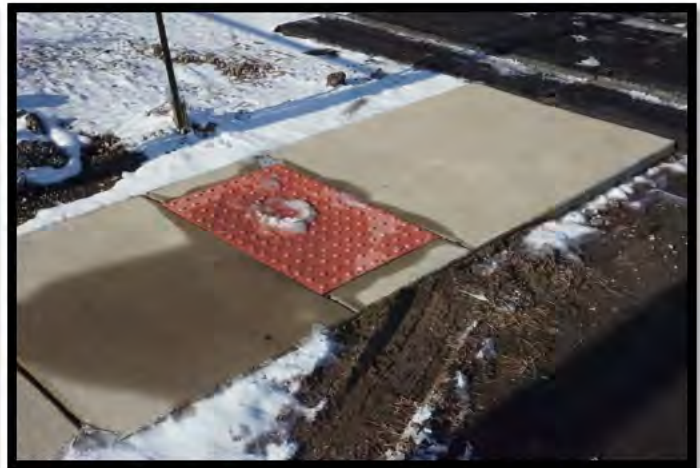
Photograph 82: End of sidewalk along railroad tracks.

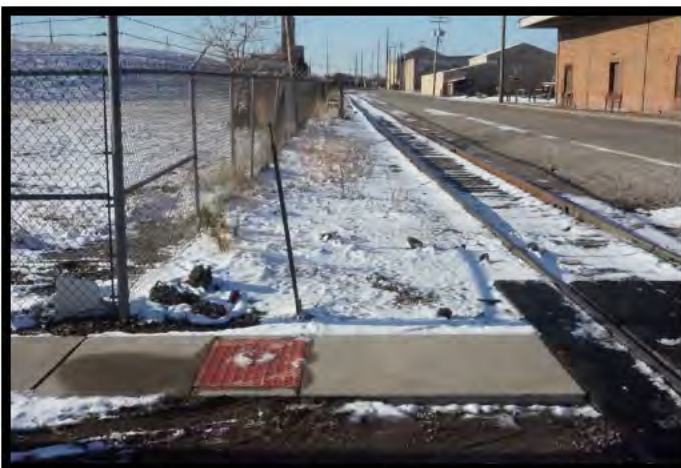
Photograph 83: End of sidewalk along railroad tracks.

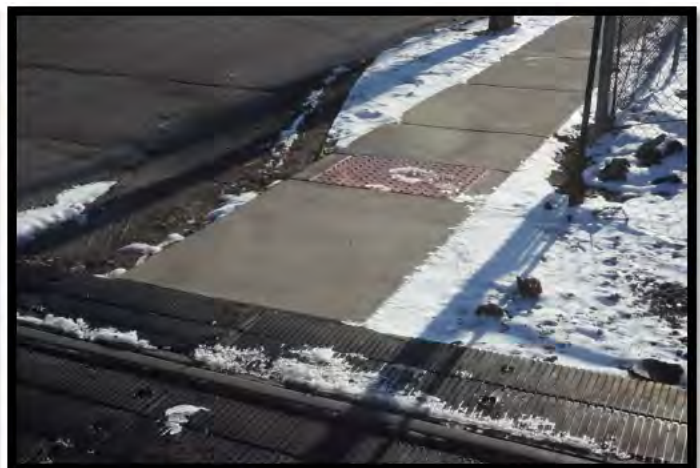
Photograph 84: End of sidewalk along railroad tracks.

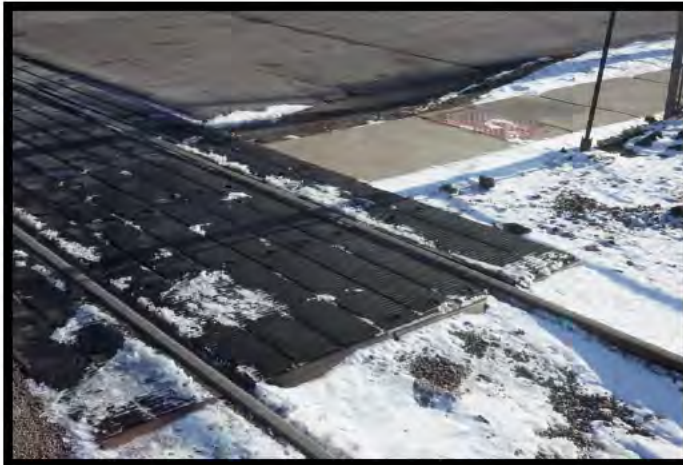
Photograph 85: End of sidewalk along railroad tracks.

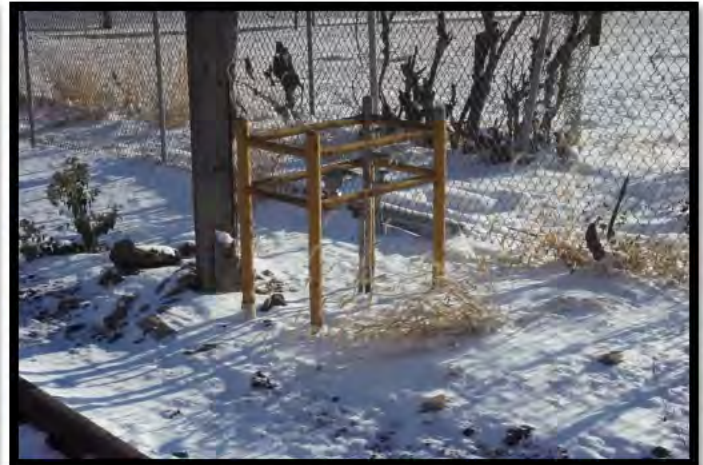
Photograph 86: Gas utilities along railroad tracks.

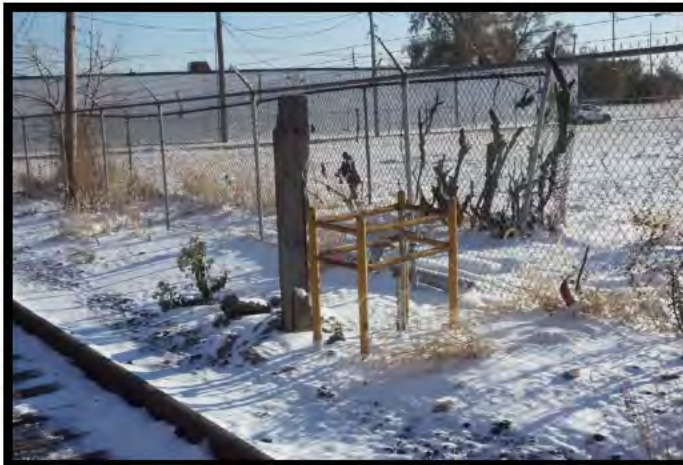
Photograph 87: Gas utilities along railroad tracks.

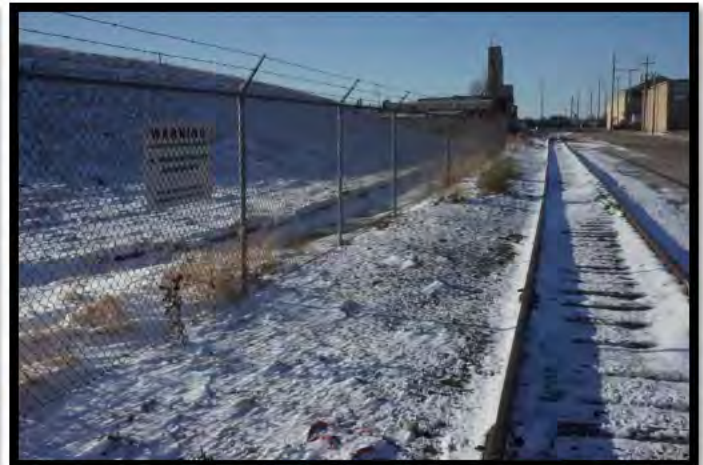
Photograph 88: Fence along railroad tracks and 16<sup>th</sup> Street.

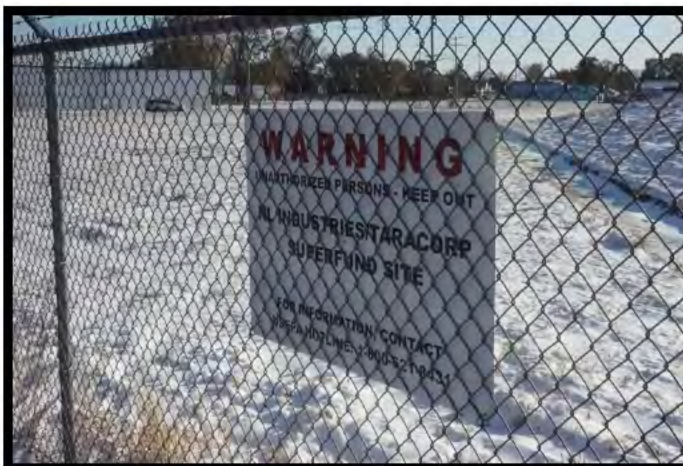
Photograph 89: Warning sign on fence along railroad tracks near 16<sup>th</sup> Street and Edison Avenue.

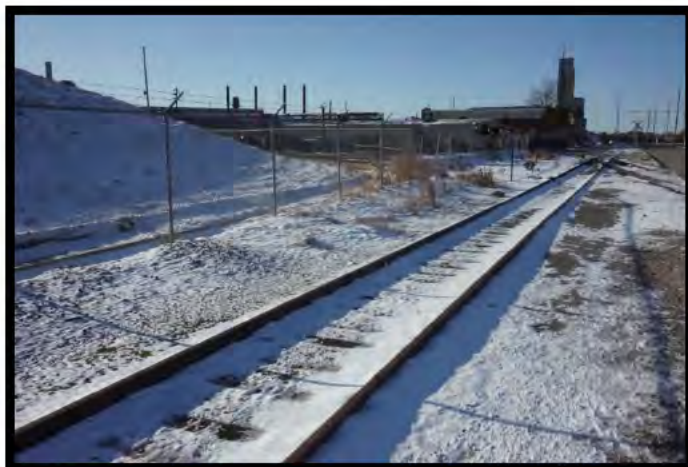
Photograph 91: Fence and vegetation along railroad tracks and 16<sup>th</sup> Street.

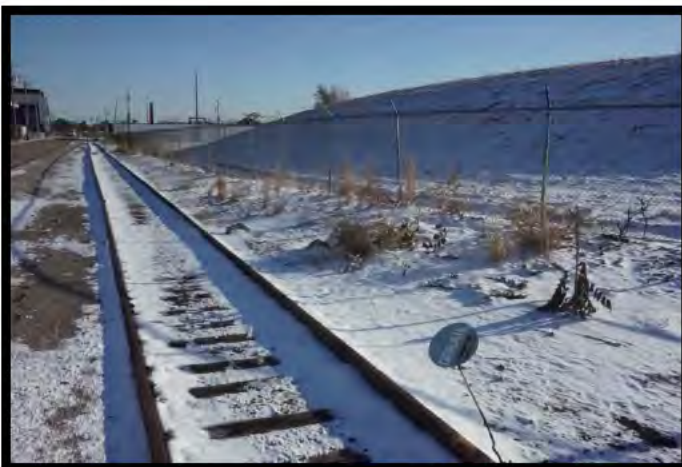
Photograph 92: Fence and vegetation along railroad tracks and 16<sup>th</sup> Street.

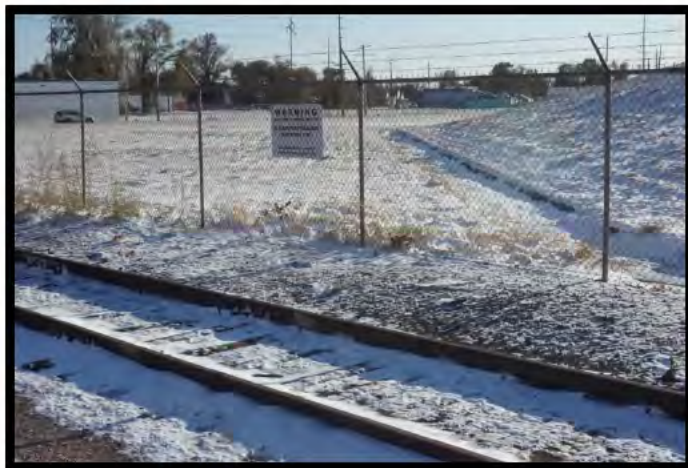
Photograph 93: Fence and vegetation along railroad tracks and 16<sup>th</sup> Street.

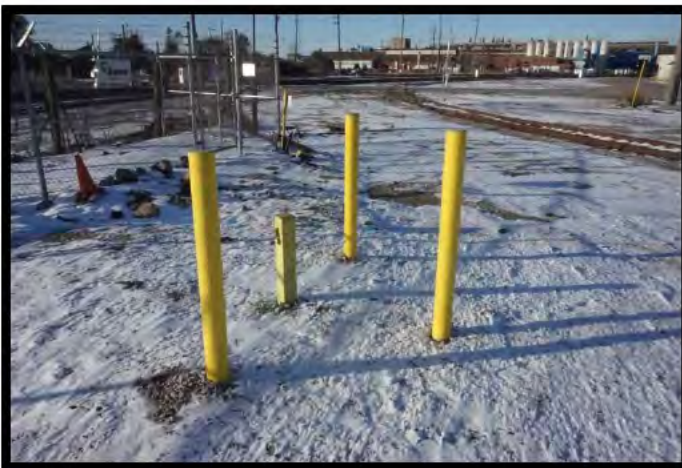
Photograph 94: Recently constructed bollards around monitoring well MW-105D.

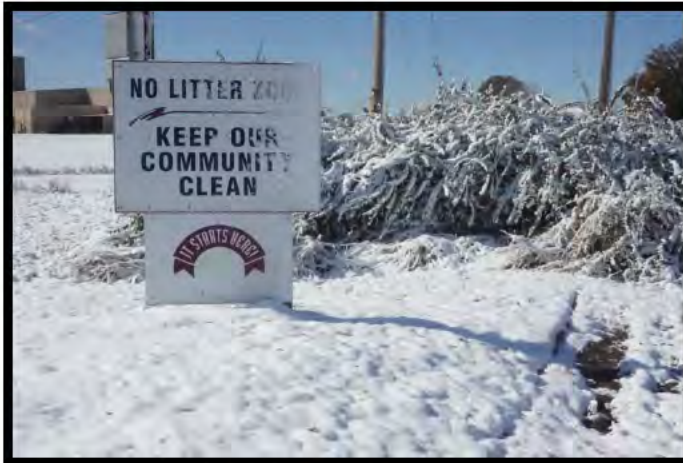
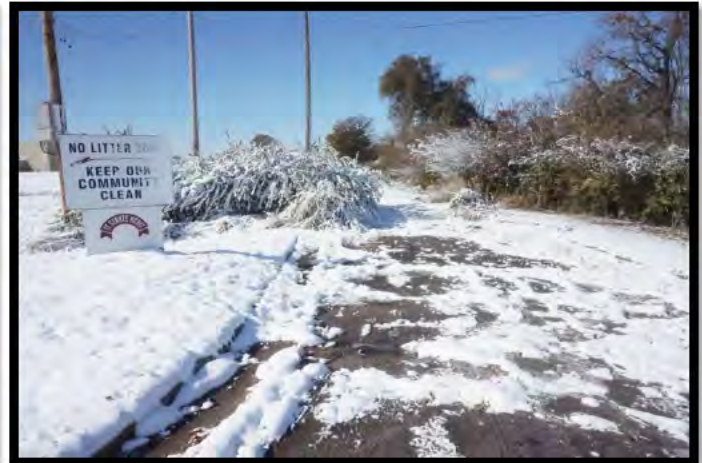
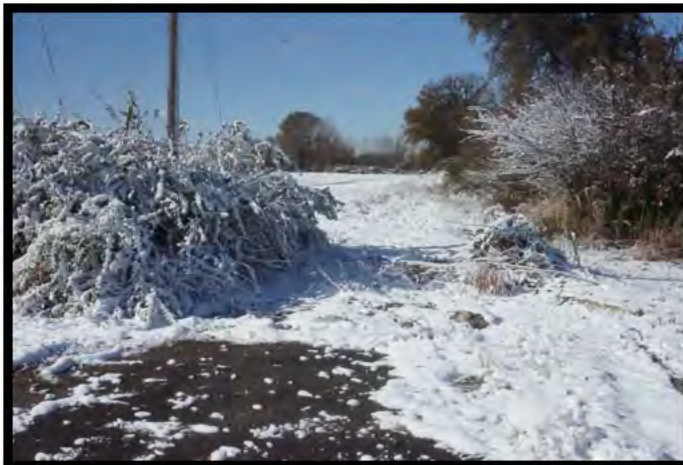
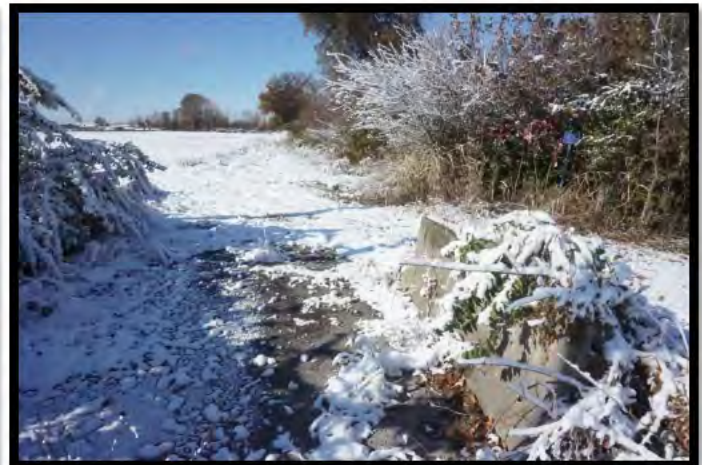
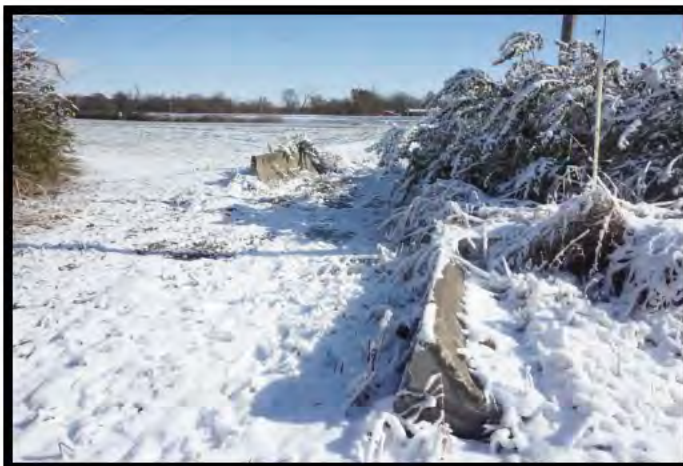
5. Remote fill properties (Schaeffer Road and Sand Road) previously remediated by EPA (and where lead-impacted soil and/or battery case chips may remain in place at a depth of three feet below ground surface) were observed during the inspection. Photographs are provided in Attachment 6 and Attachment 7, respectively. At Schaeffer Road, several scattered battery case chips were previously observed on the soil surface near the sanitary sewer manhole near the west end of Schaeffer Road at the approximate location shown on Figure 5. Scattered battery case chips and some other debris (bricks, etc.) were previously observed near the foundation area of the former building at the Sand Road property shown on Figure 6. Although these areas were snow covered at the time of the inspection, no soil disturbance was observed.

Photograph 1: Schaeffer Road property, entrance.

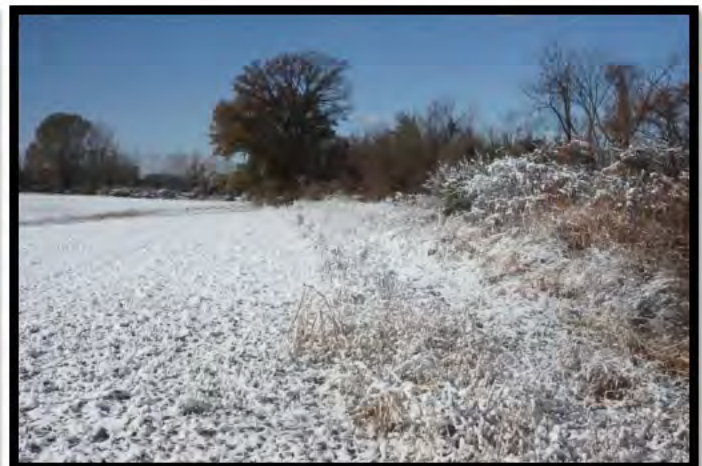
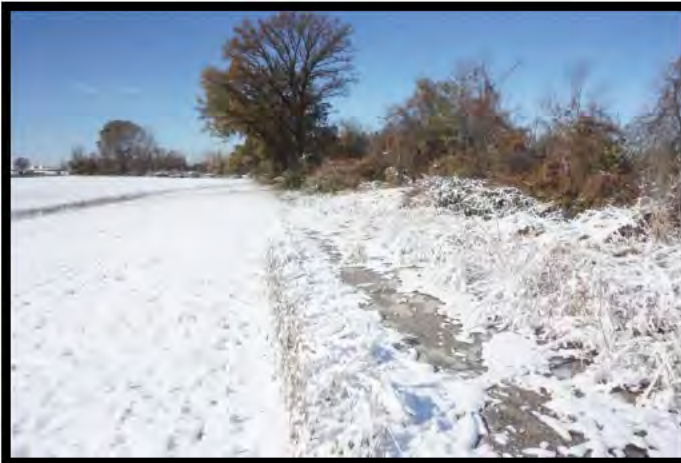
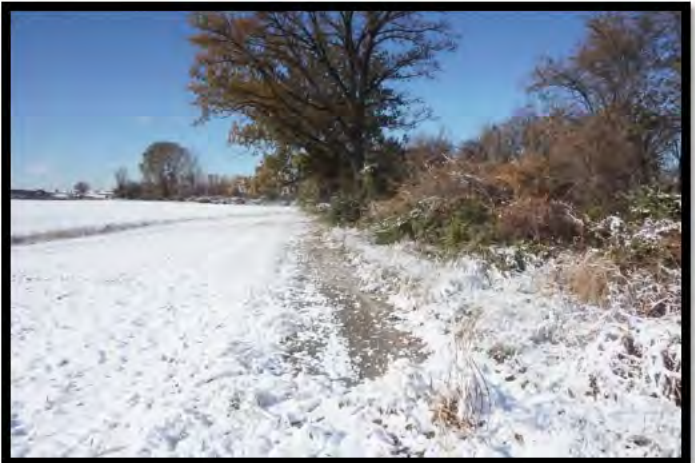
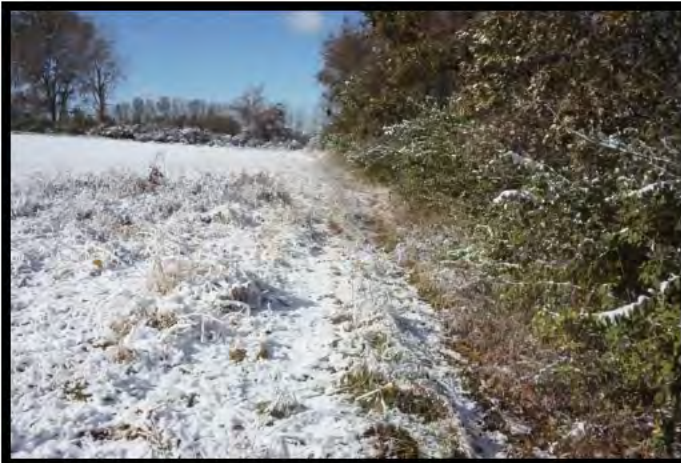
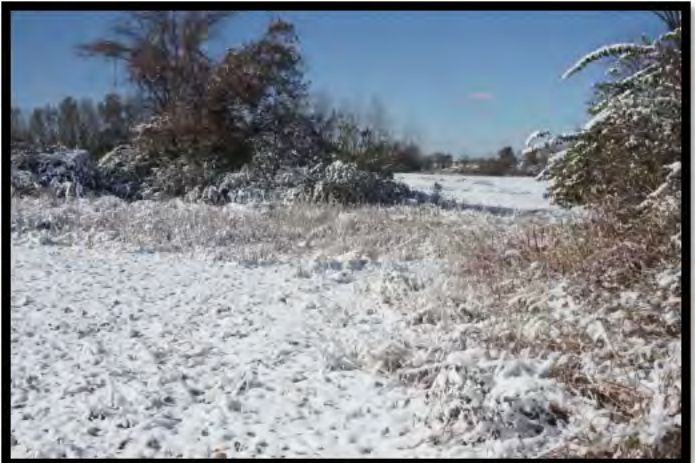
Photograph 6: Schaeffer Road property, roadway.

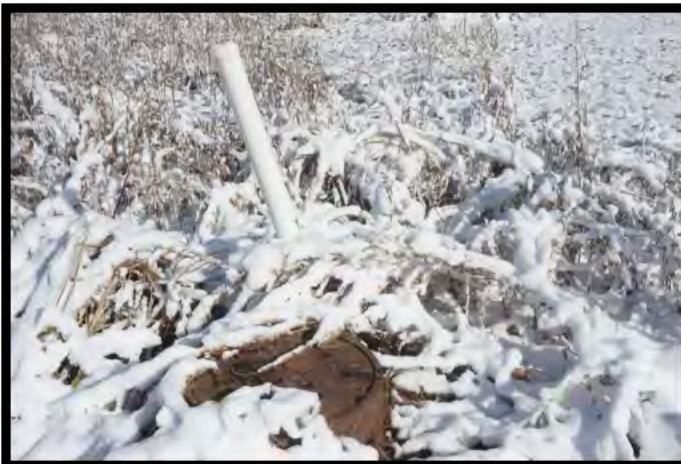
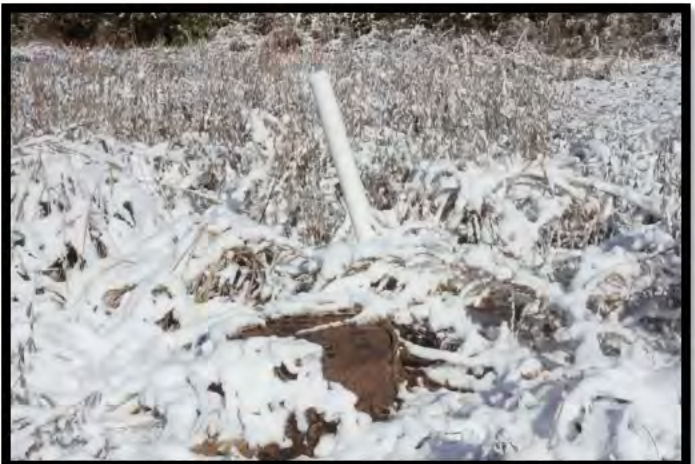
Photograph 11: Schaeffer Road property, sanitary sewer manhole.

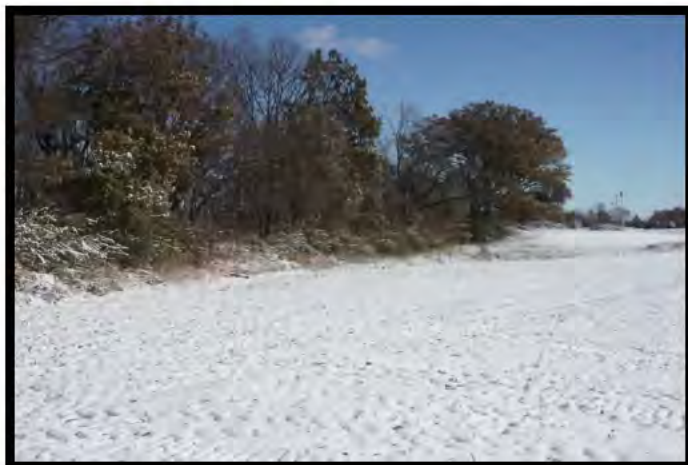
Photograph 13: Schaeffer Road property, field.

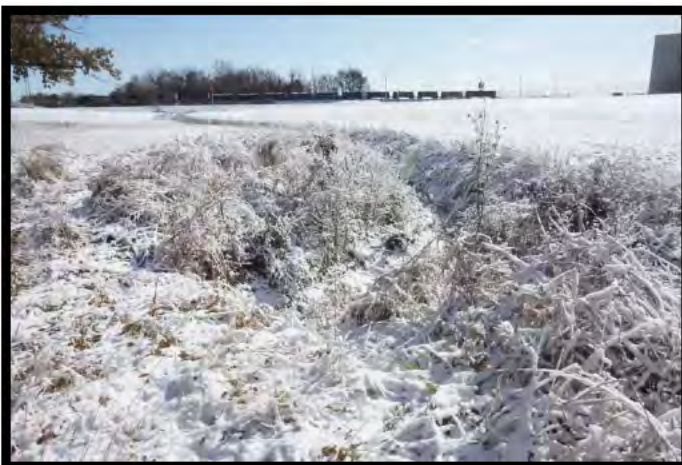
Photograph 14: Schaeffer Road property, drainage swale.

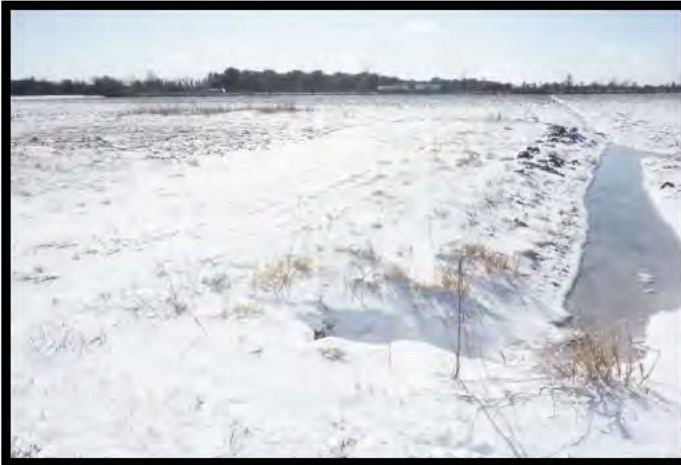
- At Sand Road (also a remote fill property remediated by EPA), some scattered battery case chips have been previously observed on the ground surface within the foundation area of a former building on the property (Attachment 7, photograph 9). Although this area was snow covered at the time of the inspection, no evidence of disturbance of the soil cover was observed.

Photograph 1: Sand Road property (view from entrance).

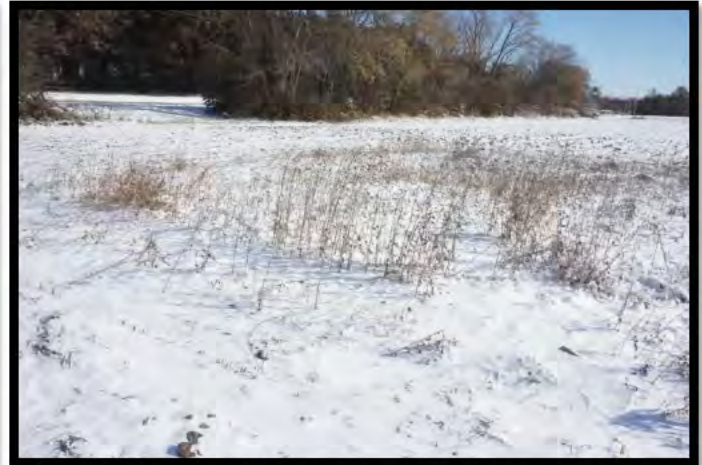
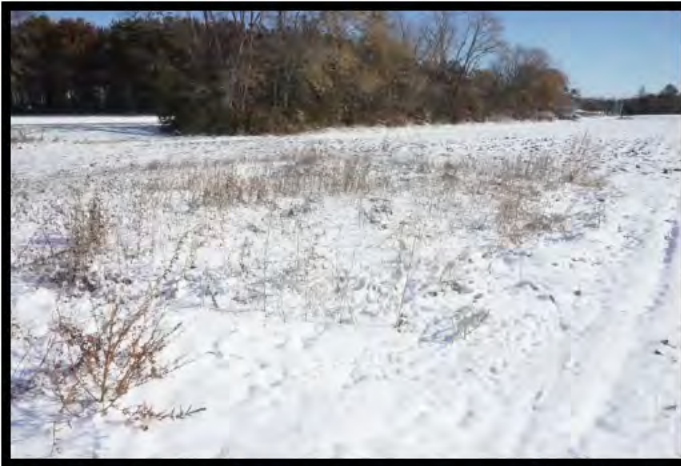
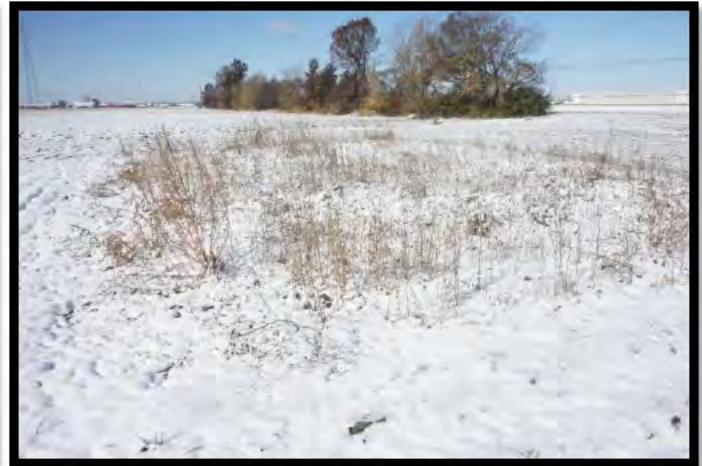
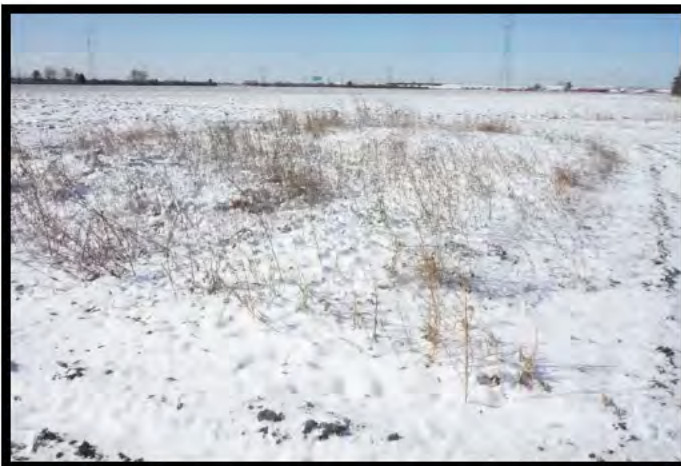
Photograph 2: Sand Road property, concrete foundation.

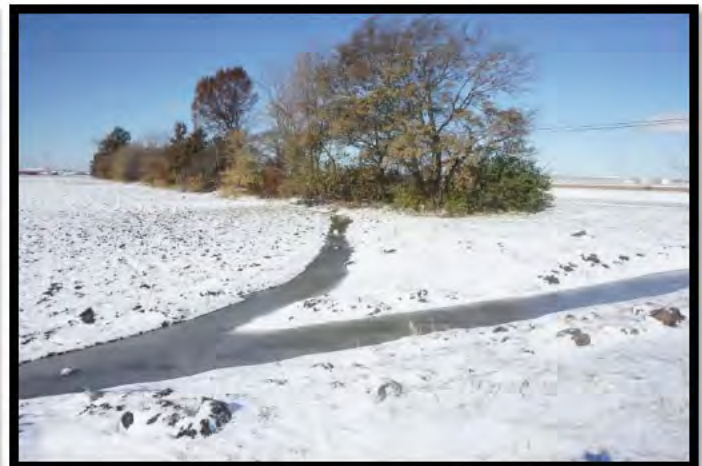
Photograph 6: Sand Road property, drainage swale.

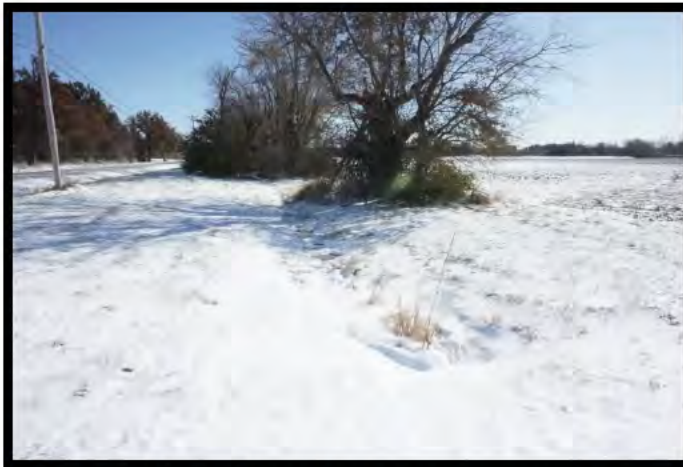
Photograph 7: Sand Road property, view east along Chain of Rocks Road.

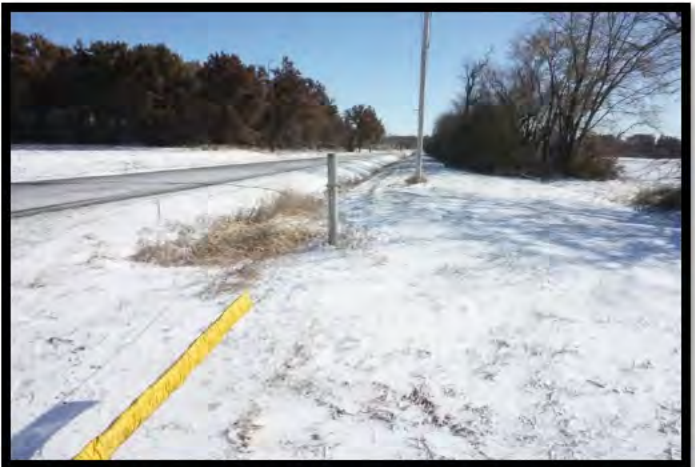
Photograph 8: Sand Road property, view east along Chain of Rocks Road.

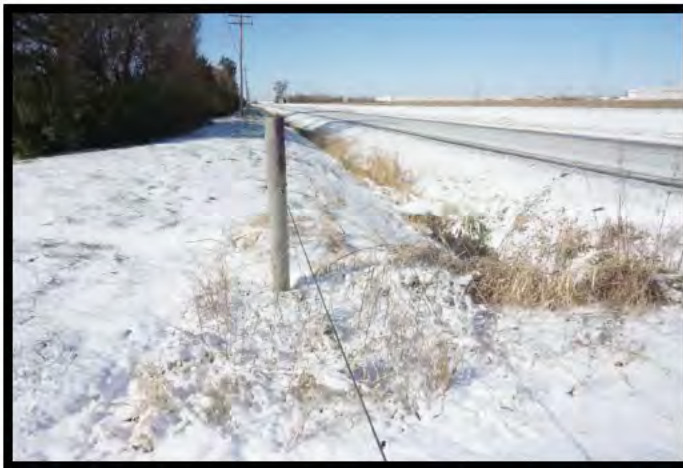
Photograph 9: Sand Road property, view west along Chain of Rocks Road.
